After the locomotive was approved for production our tool maker, trying to produce a better part with less flash, made a mistake and enlarged the slot that holds the truck sideframe. The poor fit of the sideframes was discovered during model assembly and the builders tried to remedy the situation by applying shims, believing they were fixing a sideframe peg that had been produced too small. There are two different sideframes and the belief was that only one was produced too small, so shims were only applied to that side of the sideframe pairs. The mistake and attempted fix was not communicated to the Athearn product team, and the flaw wasn't apparent during the review of production samples. Complaints about the locomotive's propensity for derailment and missing bearing cap issues prompted Athearn to look for the root cause and we were able to trace the problem back to the tooling mistake. The extra space in the gear box housing slot allows the sideframe to move vertically. There is enough movement that the sideframe can escape the hold of the bottom gear cover peg and become disconnected from the gear box housing. This movement applies pressure to the bearing caps causing them to b

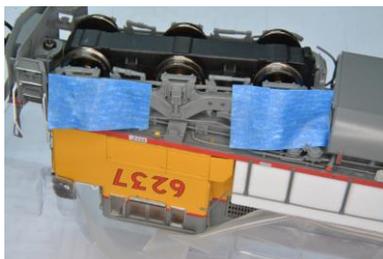
Masking tape over bearing caps

Prepare yourself and your work area for these to come off. The caps can fly away quickly to never be found again. We've included a couple extra bearing caps just in case. Placing a small piece of masking tape over the bearing caps can help capture and contain them.

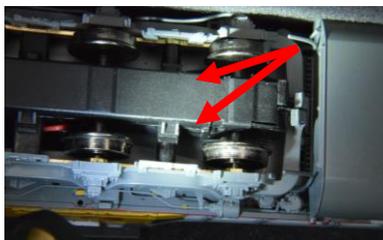
Inner clips

When all four clips have been loosened/bent/broken, you can gently pull up on the bottom gear cover. Using your pointed instrument, you can also gently pry it away from the gear box housing. This part can be thrown away.
